Introduction

- A hot tap was required on the 12” Simonette high-pressure dehydrated sour gas transmission line near Grande Prairie.
- The hot tap was completed under full line pressure and gas/condensate flow during the winter with temperatures averaging -20°C .
- The 12” transmission line gas is approximately 2% H_2S and 4% CO_2 .
- New gas through 4” hot tap tie-in was 21% H_2S and 5% CO_2 .

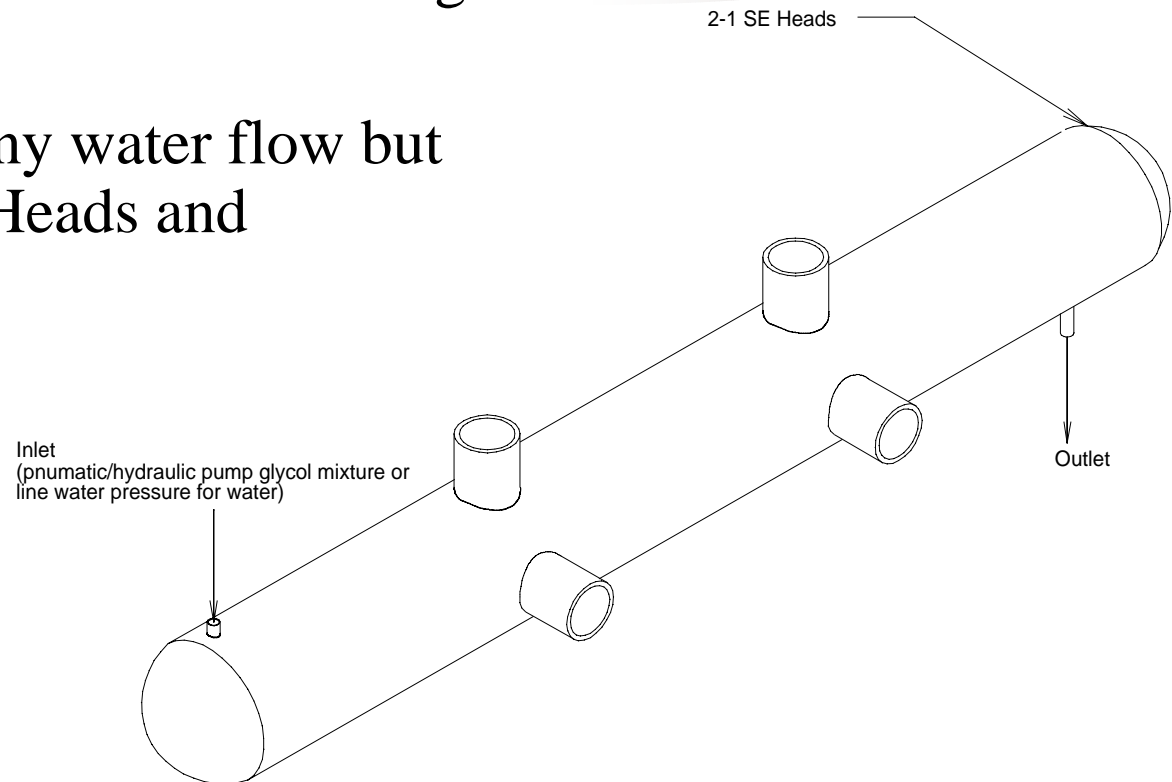
Coupon Details

- Large enough to facilitate the needs of PQR development and welder training
- Coupon similar to any water flow but was equipped with Heads and Hydrostatic tested.

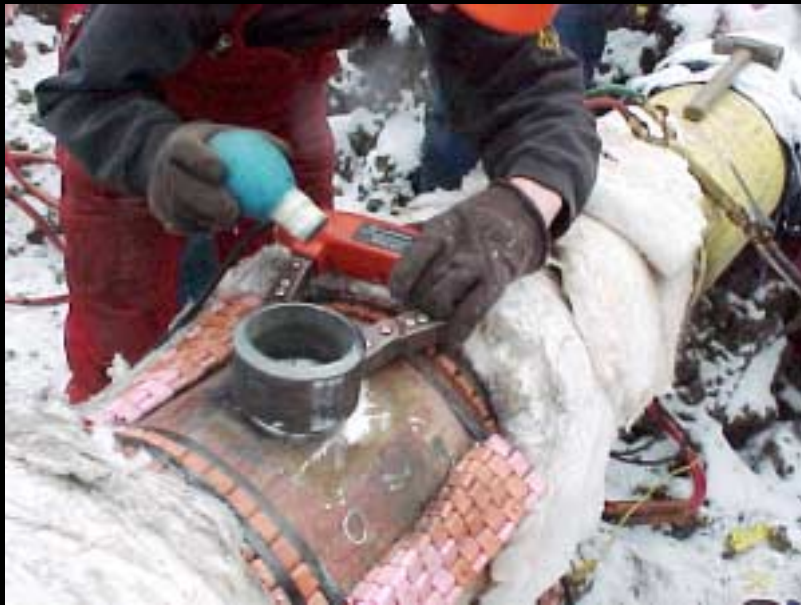
NDE During welding

- The weld was MPI inspected for cracking a several stages
 - Root pass
 - After the welding was completed
 - 24 hours after the weld was completed to check for delayed hydrogen cold cracking.

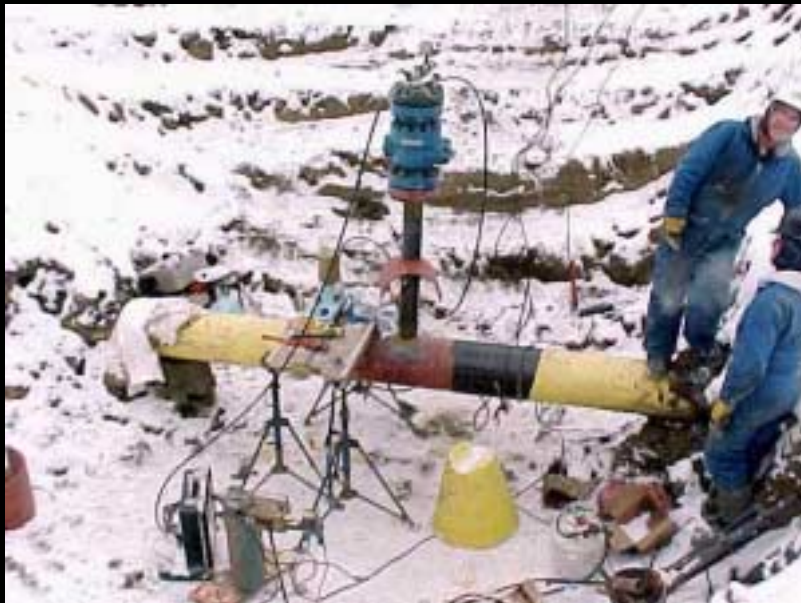
Field Welding

- The reinforcement saddle was not welded to the carrier pipe wall.

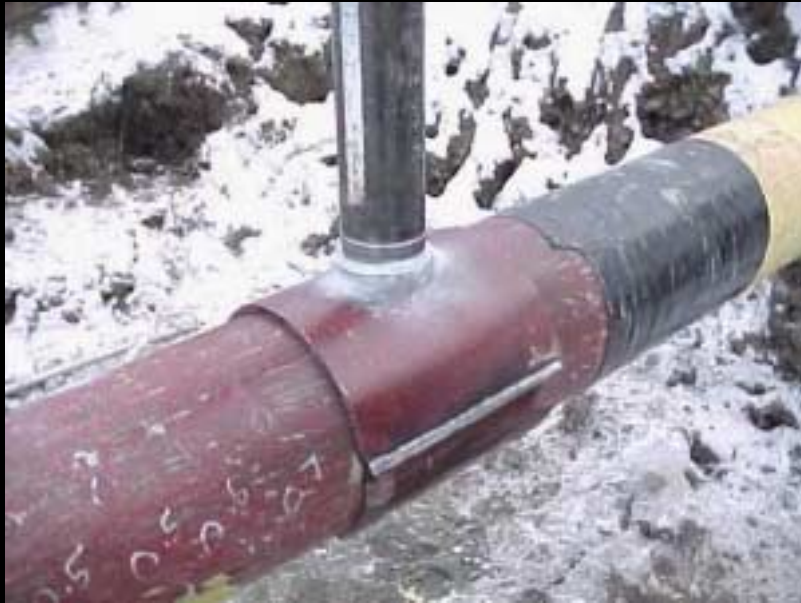
Field Welding

- The reinforcement saddle is welded to the branch connection
- The completed weld of the reinforcement saddle to the branch connection was magnetic particle inspected. (Figure 6)

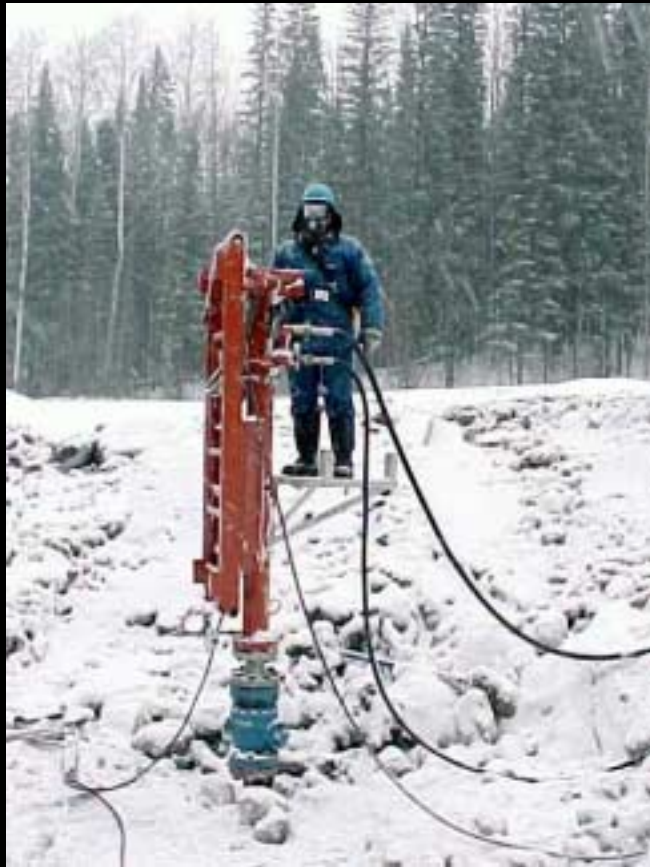
Hot tap

- During the actual hot tap into the pipeline the machine operator was masked up and using supplied breathing air apparatus,
- H₂S detection was in place and a rescue crew was standing by.
